# Disaster recovery - at the sharp end

## Flooding and disaster planning at The Royal London Archives and Museum

Jonathan Evans, Archivist and Curator  
September 2006

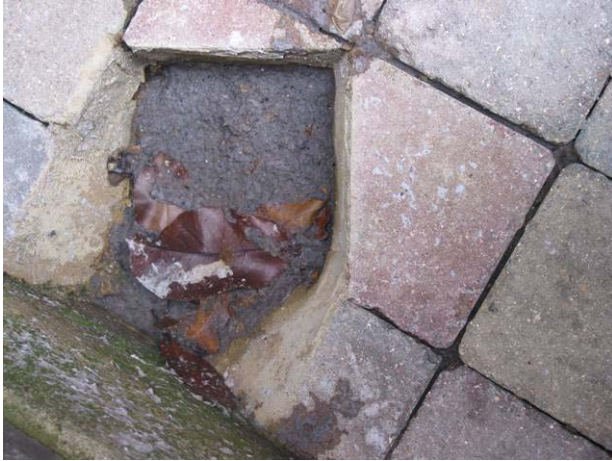
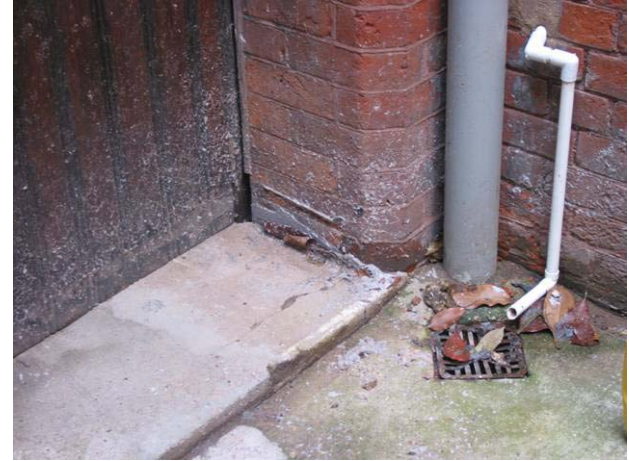
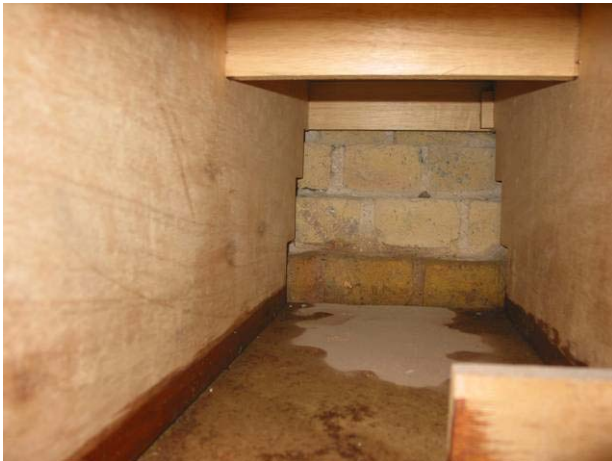
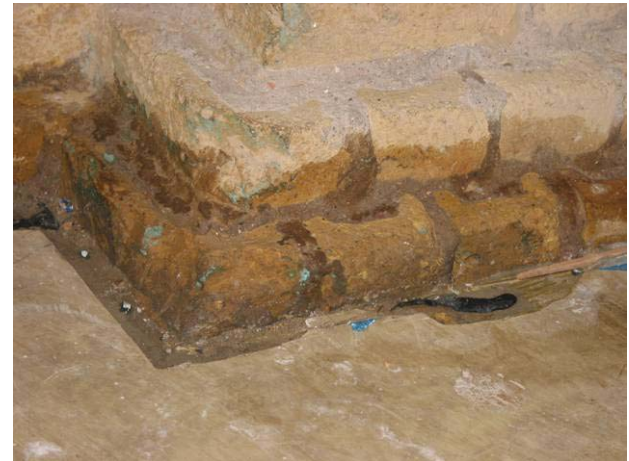
# Blocked drains and museum on 14.6.06

- Flood resulted from blockage in the drainage system (caused by piece of masonry lodged in the sewer outflow pipe)
- Exacerbated by installation of new toilets (disabled and non disabled in building in early 2006.
- At 16.00 on that day 1.5” of rain fell in 20 minutes at Whitechapel
- Museum being invigilated by volunteer who contacted assistant archivist and records manager working at Prescott Street. Access to the list of contacts in disaster plan is particularly important if there is a volunteer supervising the area when disaster strikes.

- Camera investigation of drain system revealed source of the problem.
- Floor replaced – laminate was unsuitable – new floor is glued to the base and is suitable for use in bathrooms and kitchens
- College insurance covered floor. NHS insurance did not cover loss of publications stock, damaged display boards or Flesh and Blood posters.
- Museum reopened after 2 week closure.

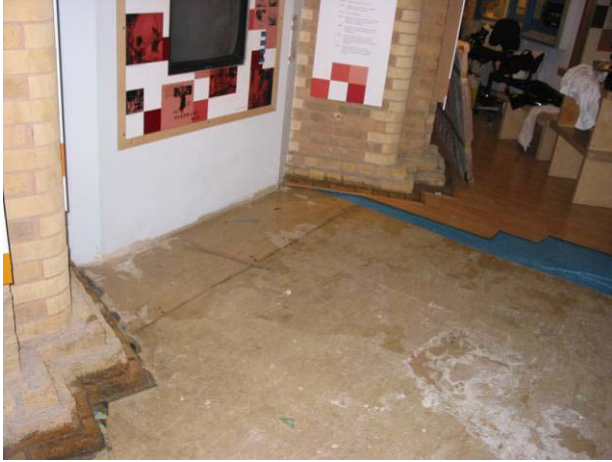
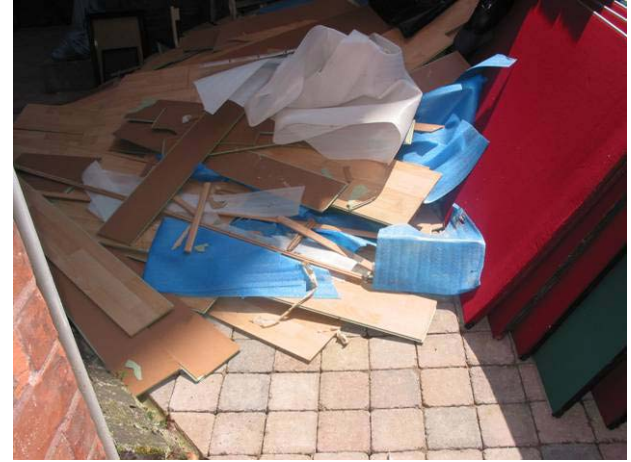
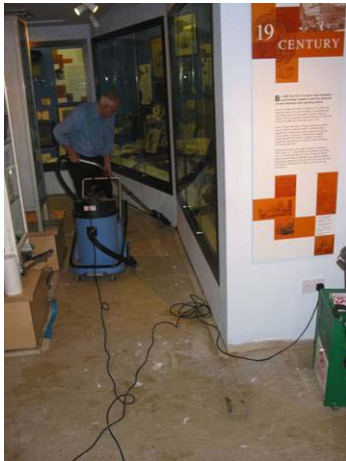
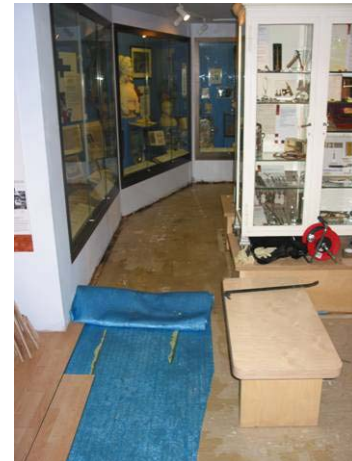
# Clean up photos 14/15.06.06

- Due to large number of call outs on 13<sup>th</sup> June, Thames Water contractor only arrived next day – until then College Estates installed a pump to reduce water level
- Industrial strength Aquavac was essential to clean up
- 4 dehumidifiers rented next day – retained for duration of museum closure and thermohydrographs installed and monitored very regularly
- Until source of blockage was identified, constant vigilance was vital to minimise risk of further flooding.
- When lifted laminate floor a potential health hazard

- Archivist and a technical manager worked with estates staff to remove flood water a.s.a.p.
- 100 aquavac buckets removed from the museum on the day of the flood
- Archivists and records managers packed up office equipment, undamaged publications stock, etc. next day
- New floor quoted for, commissioned and installed within 10 days of the flood.
- Cleaners used antibacterial spray on brickwork etc.
- Additional vents installed in showcases to assist drying process.

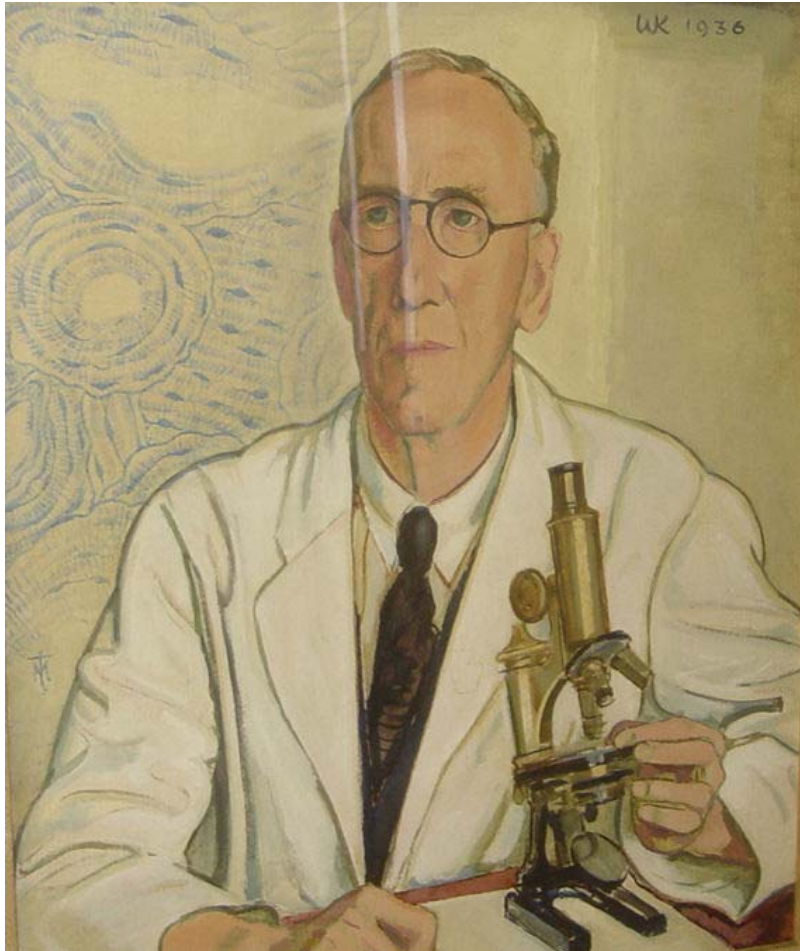
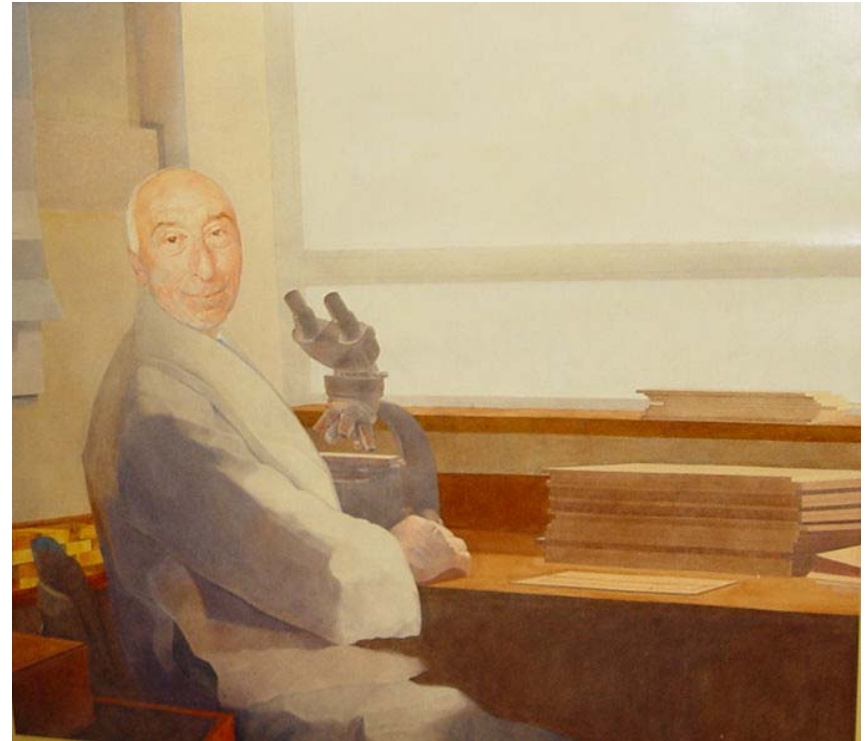
# Damage to two frames / mounts

- Insure for all risks and changes of location – two pictures which had frames damaged were wrapped but were resting on floor as they had just been accessioned and were awaiting transfer to picture racking
- Have a digital camera ready so you can take pictures of damage to premises and individual items a.s.a.p.
- Get your conservators to look at damage a.s.a.p.
- 4 portable dehumidifiers were hired: essential in avoiding damage to museum exhibits / fabric: know how to access these

- Temporary museum closure allowed time to make minor adjustments / improvements to museum displays
- Humidity levels in museum cases average 60% in the 5 month period following the flood
- Damaged paintings currently undergoing conservation: this work has been covered by insurance. Damage to temporary display boards / posters was not covered by insurance.
- College Estates continue to check drains regularly
- Museum visitor figure have returned to seasonal norm, but some Trust and College staff think museum is still closed
